# MARIAVILLE LAKE DAM ENGINEERING ASSESSMENT REPORT

## MARIAVILLE LAKE CIVIC ASSOCIATION

Project No. 240647-000R  
January 2025

## **MARIAVILLE LAKE DAM ENGINEERING ASSESSMENT**

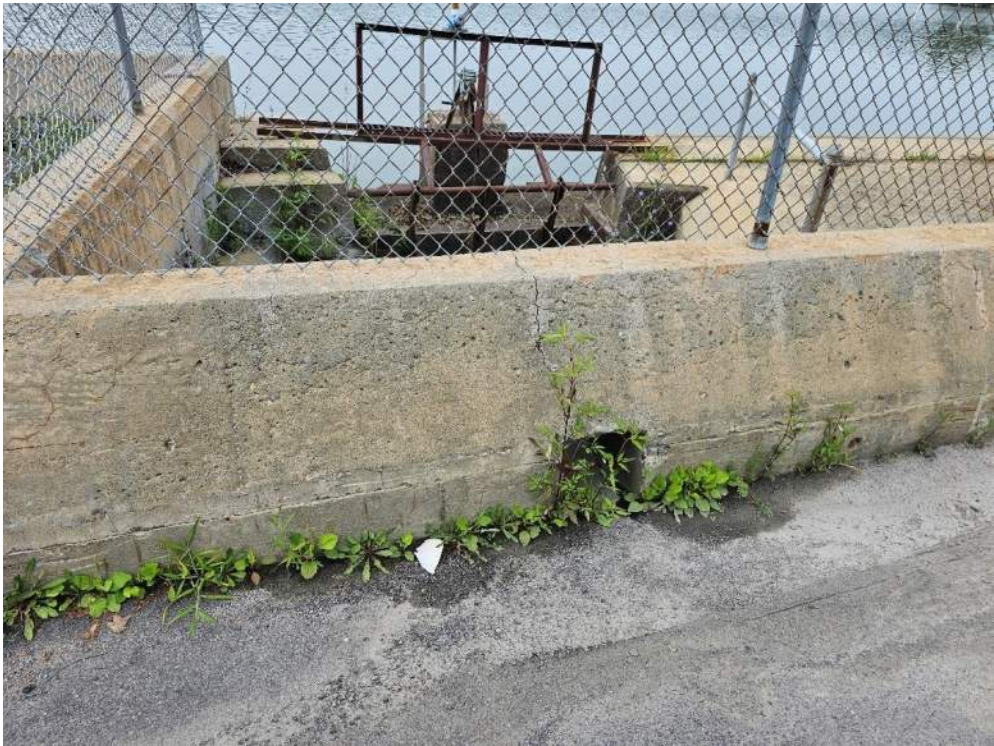
Downstream Face of Drop Inlet – Crack Above Drainage Slot

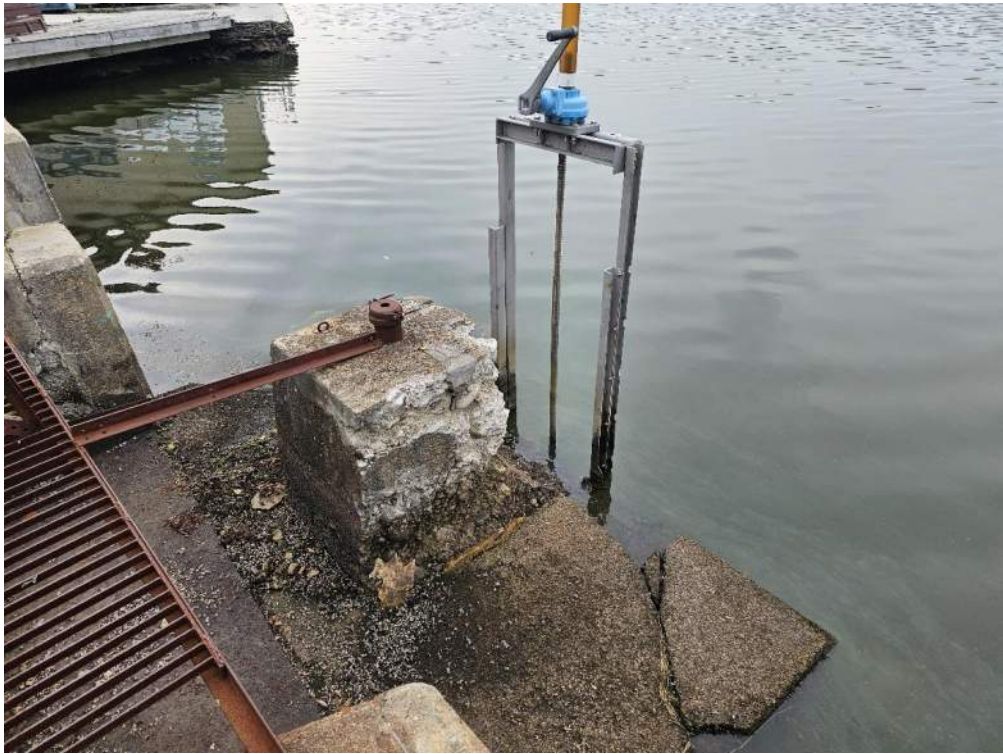
walls. There is also a loose piece of concrete at the corner of the structure where the slide gate is mounted.

Abandoned Low Level Outlet Structure with Face Mounted Gate Frame and Cracked Concrete Structure

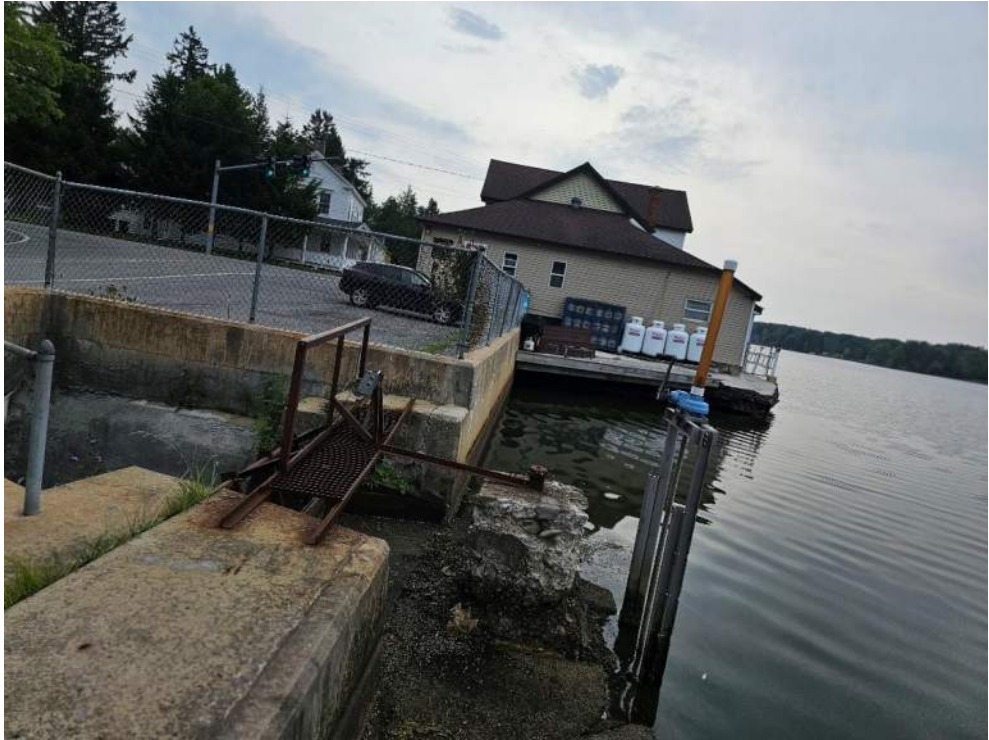
Spalled Concrete at East Spillway Wall and Abandoned Low Level Outlet Valve

As of November 5, 2024 most of the repairs recommended in this report have been completed including repairs to spalled areas of concrete, cracks have been sealed, vegetation removed from cracks and concrete joints, and the lag bolts in the slide gate frame have been replaced. Recommended repairs from the safety inspection that have been completed are noted as completed on the proposed schedule in Exhibit J. Photos showing the recently completed repair work are included in Exhibit K.

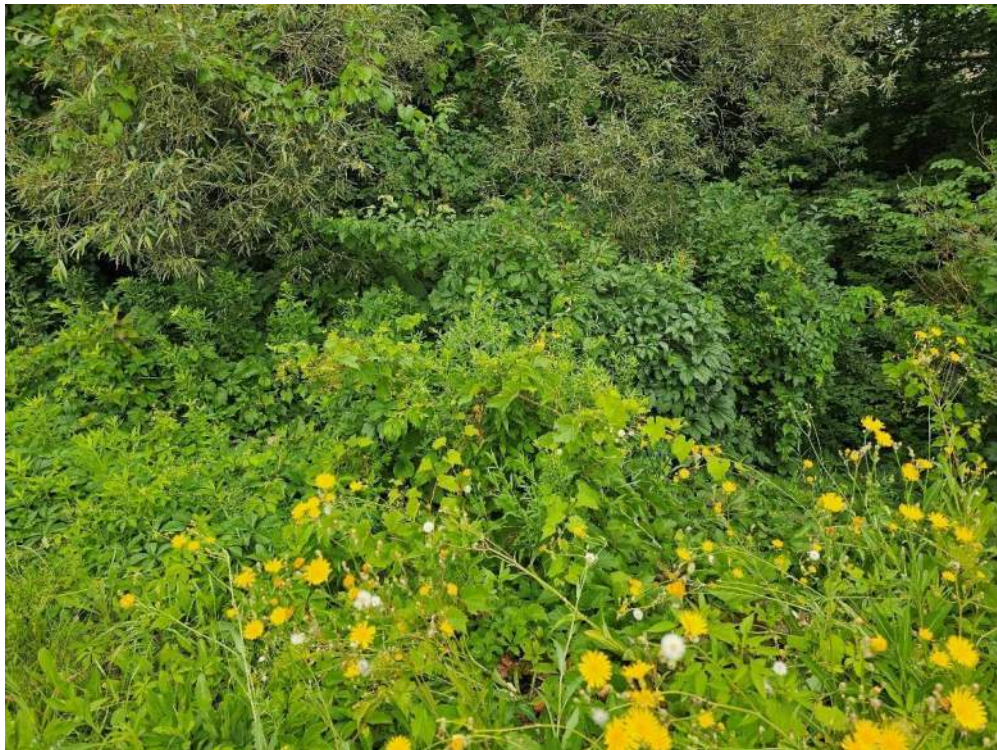
- There are (2) lag bolts missing from the slide gate frame.
- The visible portions of the concrete headwall appear to be in good condition.
- The downstream embankment is overgrown with vegetation and should be mowed to allow for inspection and access. It should be noted that this embankment is not owned by the MCA.

Downstream Embankment Looking North

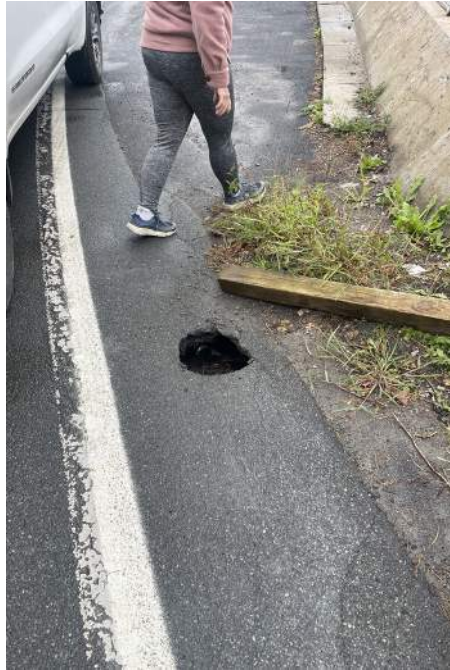
On September 30, 2023, a small sinkhole was observed on the shoulder of Batter St on the backside of the dam, near the end of the western abutment. The County repaired the sink hole on October 4, 2023. The pavement was saw cut and removed down to approximately one foot below the surrounding sound pavement. Subbase material was installed, compacted, and a patch of asphalt was installed over the area. It should be noted that the water surface elevation of the lake was below the road at the time the sink hole was observed, and there were no visible whirlpools or turbulence in the lake.

Due to the location of the sinkhole, and the results of the diver's inspection report from June 2024, it appears that the condition of the existing retaining wall adjacent to the dam may have led to the formation of the sinkhole. The dive inspection noted that the retaining wall is deteriorated while the face of the dam is sound and in good condition. Therefore, it appears likely that the retaining wall may not be watertight and could allow water to pass through and make its way behind the concrete dam face.

Sinkhole behind western dam abutment as discovered on 9/30/23

Ownership of the retaining wall should be confirmed prior to the design of any repairs. It appears that the wall may be owned by the County. It is recommended that the retaining wall be replaced with a cast in place concrete wall to ensure water tightness. The retaining wall should be sealed against the dam abutment to protect Batter St and prevent water from making its way around the end of the dam abutment.

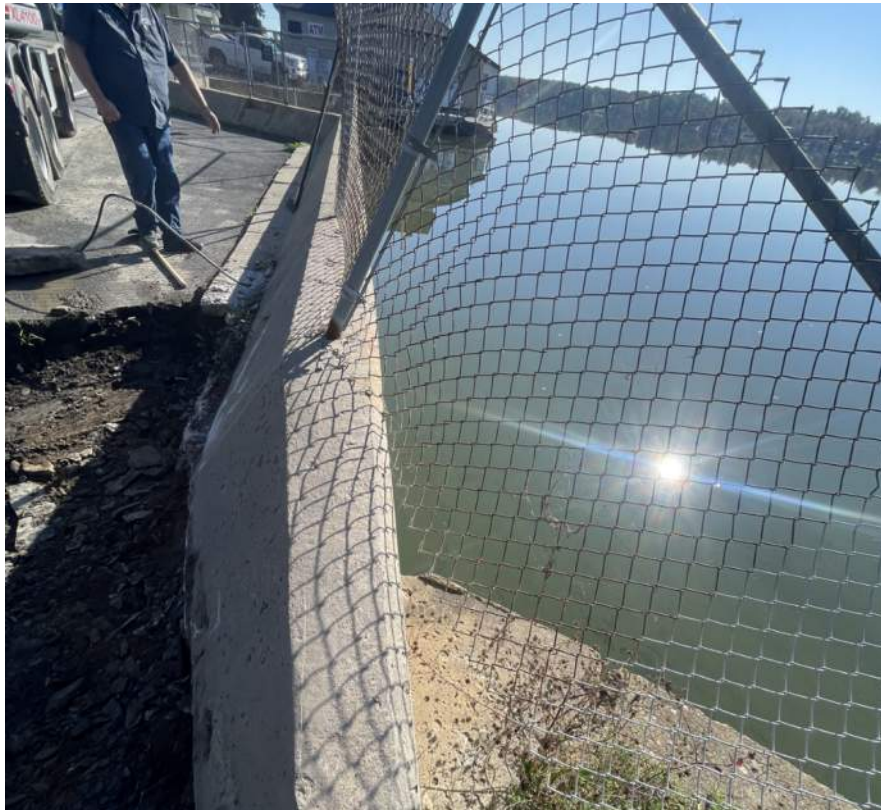
Lake water surface elevation below sinkhole area
